### **Appendix F**

#### **Interim Report on Inventory and Identification of Steels Recovered from the WTC Buildings .....**

# **INTERIM REPORT ON INVENTORY AND IDENTIFICATION OF STEELS RECOVERED FROM THE WTC BUILDINGS**

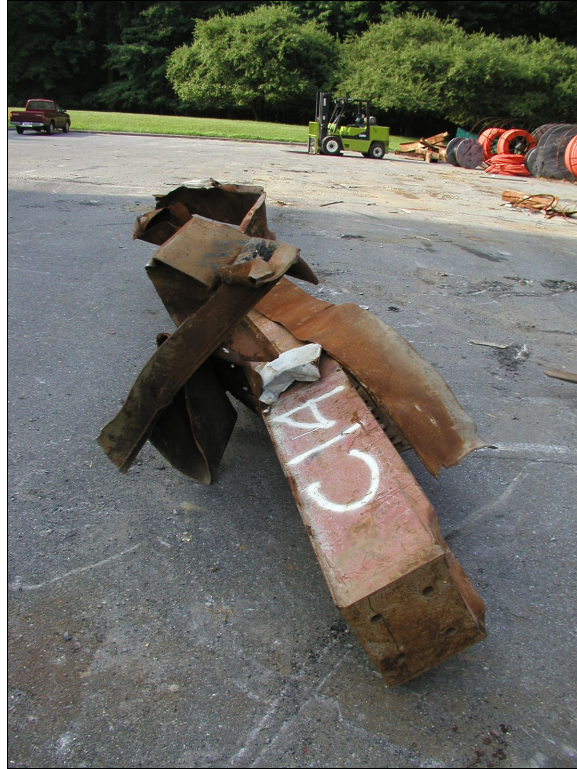
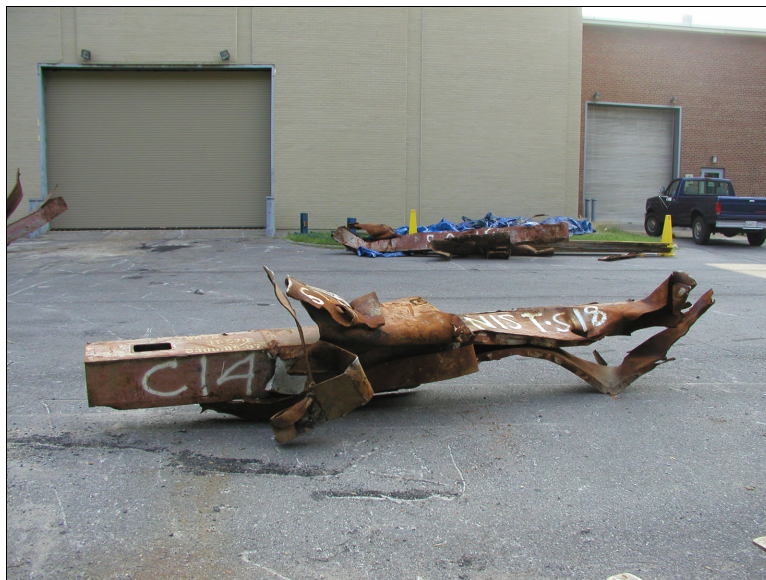
**Figure F-1. Characteristic “overall” view of the samples taken for each piece received. Sample shown here is C-14.**

As samples were delivered, overall images of the pieces were taken for record-keeping purposes. An example is shown in Fig. F-1. Samples are identified by their original alphanumeric identification codes assigned by SEAoNY to be consistent with the FEMA report. However, there were cases in which two different codes were found on one piece. In these instances, if the pieces were already undergoing

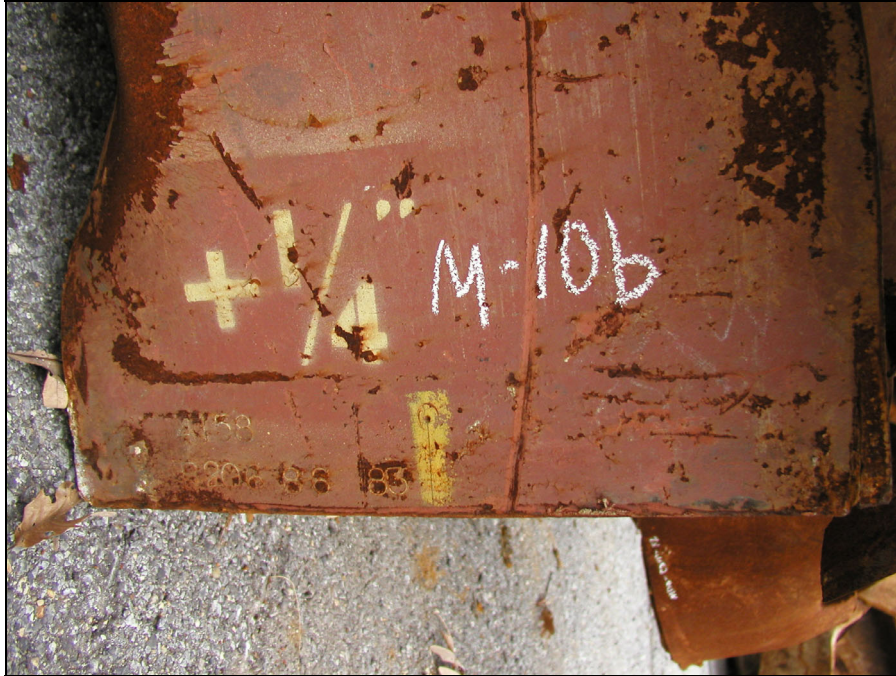
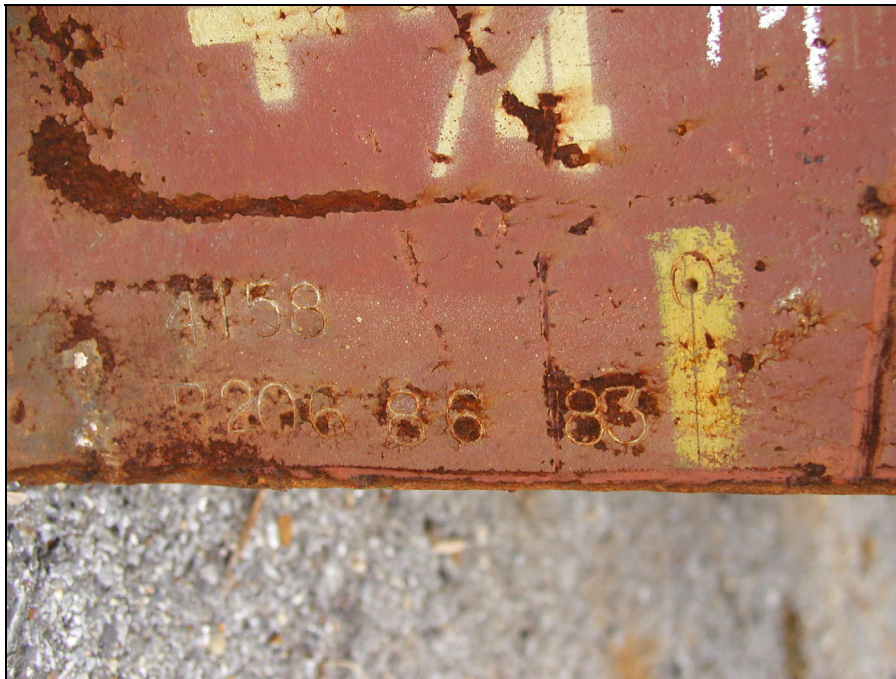
**Figure F-3. Example of stampings on the interior base of the middle column for each panel.**

lower end of the component near the connector. The building was typically represented as “A” for WTC 1 and “B” for WTC 2. An example of a stamping found on an exterior column is shown in Fig. F-3, where the stamping indicates that the piece was from WTC 2, with center column line number 206, spanning floors 83 through 86. Core column material was found to have similar markings (Fig. F-4). Other stampings have also been found on the flanges of the perimeter columns that indicated the column type (Fig. F-5 and Table F-5) as well as the specified minimum yield strength of the column. Additional stampings are located on the flanges, but are not yet understood.

NIST is still investigating the significance of these codes. All of these stampings typically reside within 1 meter from the bottom of the column.

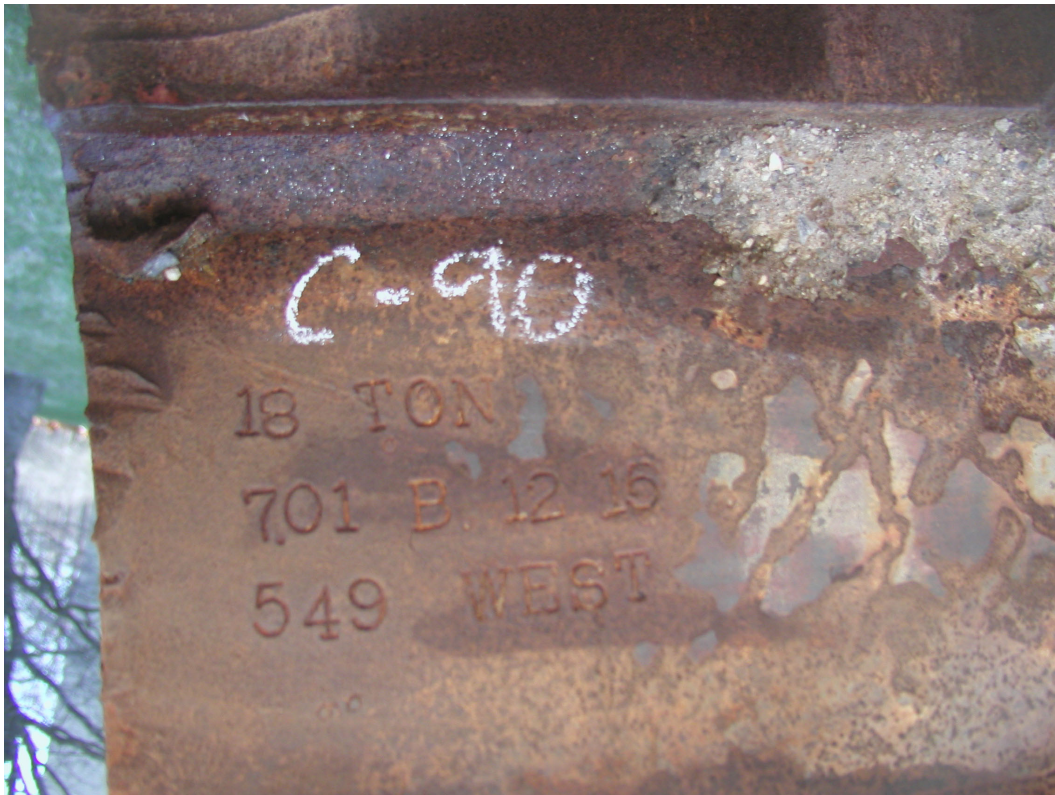
**Figure F-4. Example of stampings placed on one end of a core column.**

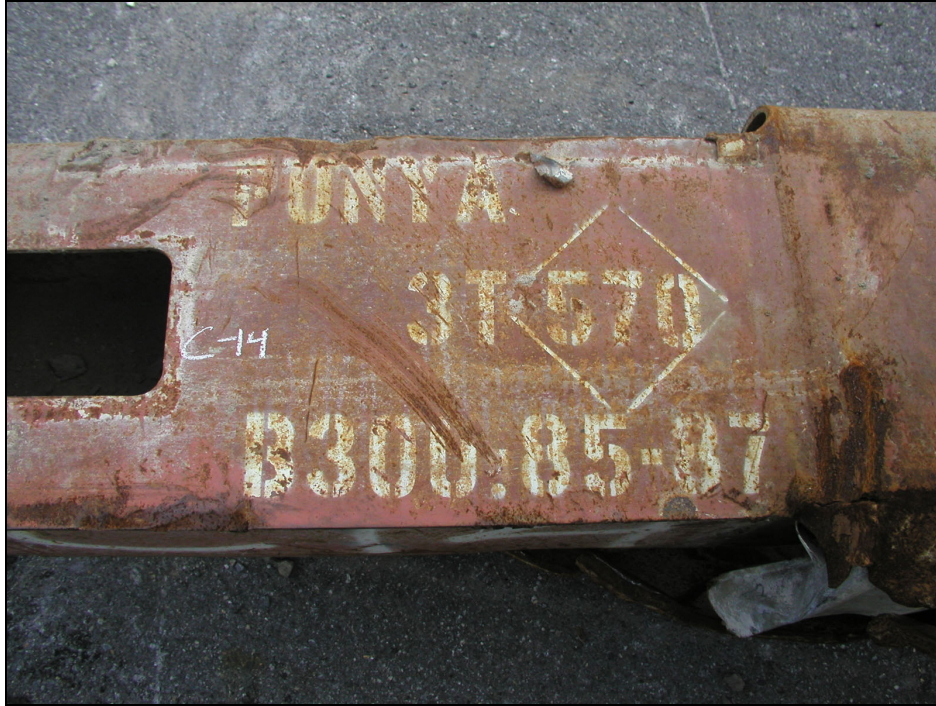
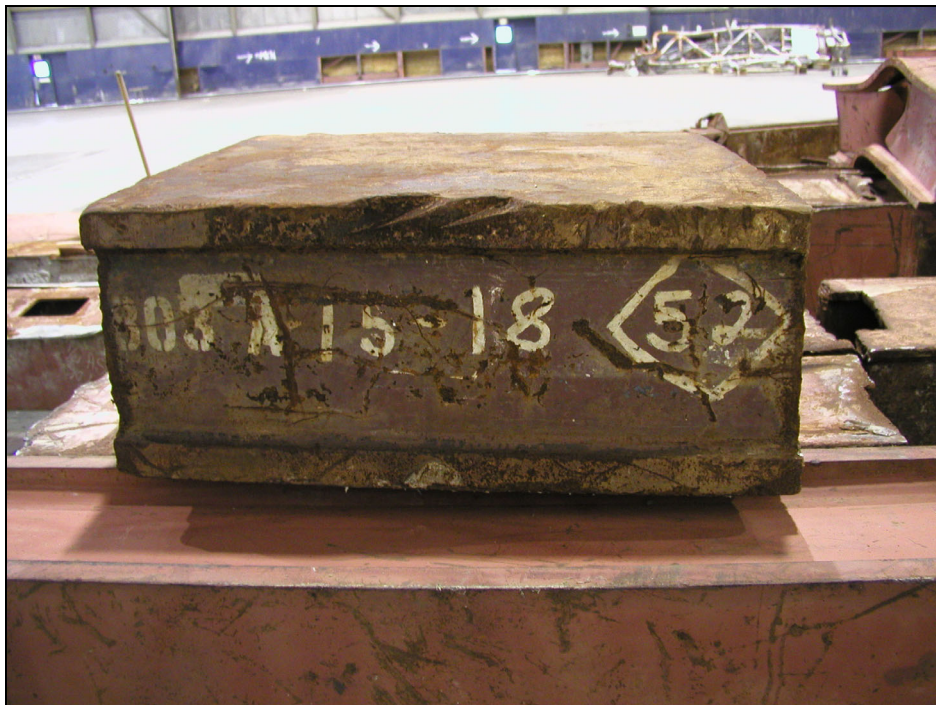
Figure F-6. (a) Characteristic stenciling found on the lower portions of the exterior column panels for sample C-14. (b) Characteristic stenciling found on an interior core column for sample B-6152.

Each of the structural elements was additionally stenciled in white or yellow lettering with similar building information. For the exterior panel sections, the stenciling was located on or near the lower spandrel on the interior face. Figure F-6 (a) shows a typical stenciling found on a perimeter panel, indicating this piece was in WTC 2, with center column line number 300, spanning floors 85 through 87. For the core columns, both stenciling and handwritten codes have been observed on the recovered pieces. Figure F-6 (b) shows one of these stencilings from a core column located in WTC 1.

Also seen in Fig. F-6 (a) are two other indicators, 3T and <570>, found on the exterior panel sections. These markings are the estimated piece tonnage (1 ton equals approximately 907 kg) and the erector's derrick division number, respectively. This information was also stamped on some of the core column pieces (see Fig. F-4). The erector, Karl Koch Erecting Co., Inc., assigned derrick divisions 47 through 70 for WTC 1 and derrick divisions 547 through 570 for WTC 2 (PONYA 1967). Each division was assigned to a specific area of the building and shared a crane with other nearby derrick divisions. Therefore, a single crane may have lifted pieces from derrick divisions 65, 67, and 69. Figure F-7 shows the derrick division numbers that hoisted the specific columns for both buildings, according to the derrick numbers found on structural elements with positive identification (also shown in Tables F-2 and F-3).

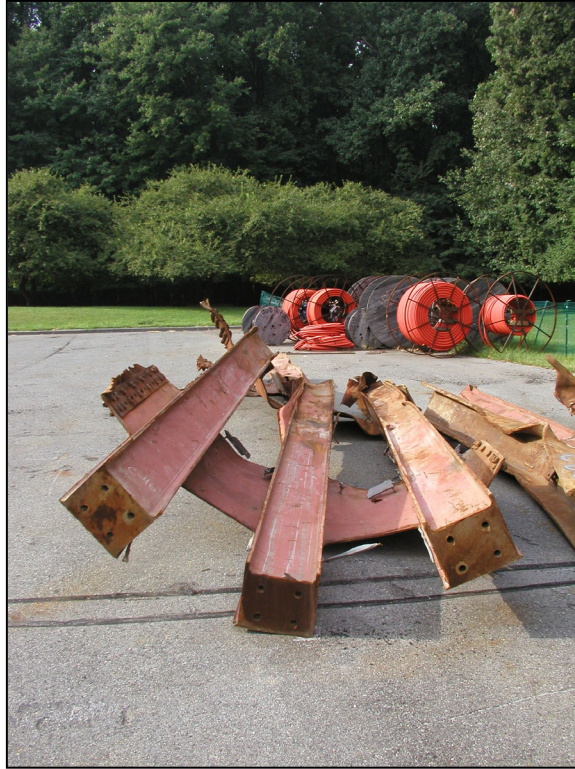
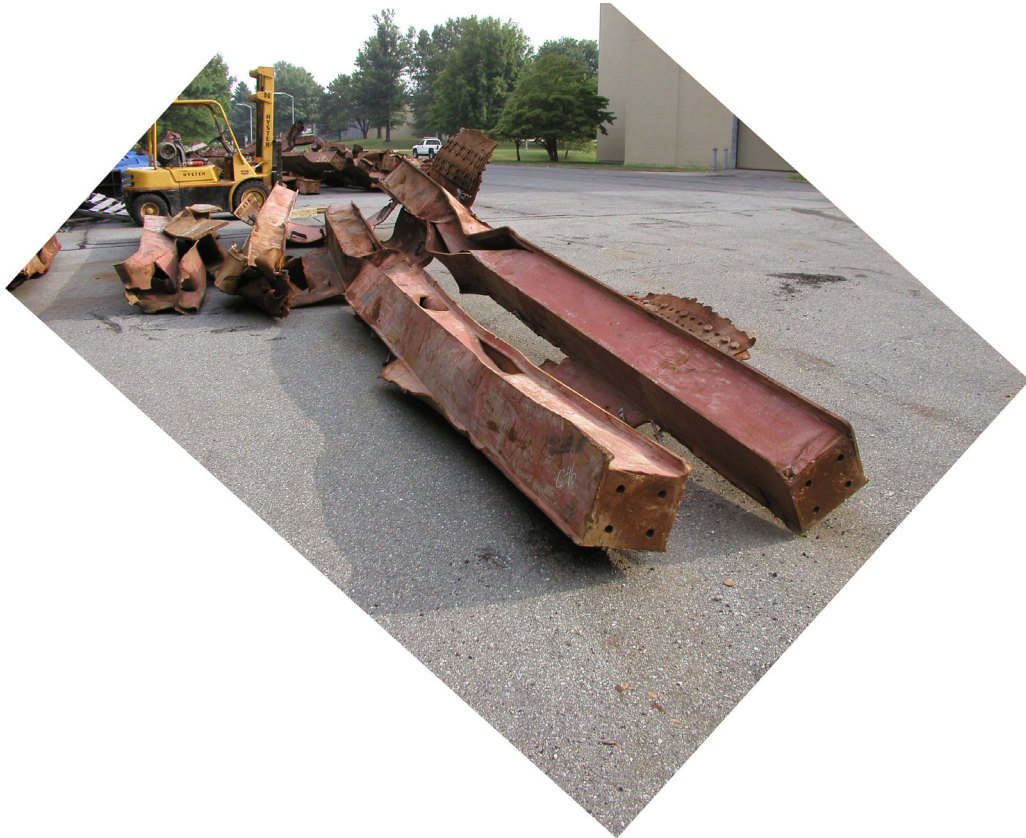
**Figure 1–1. Exterior column panel, sample C-46 shown.**

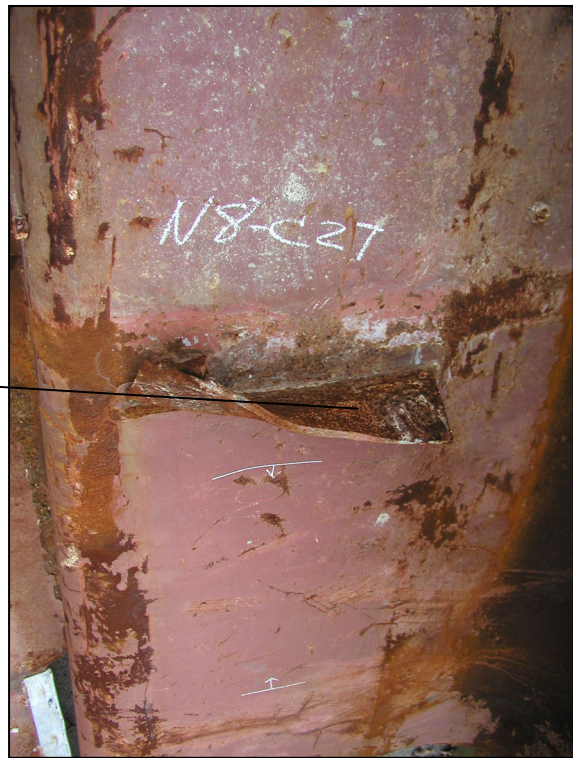
Welded gusset plate used in place of seat on alternate column/spandrel intersections. One method used to attach diagonal bracing strap to exterior wall

**Figure 1-4. Gusset plate shown from sample N-8.**

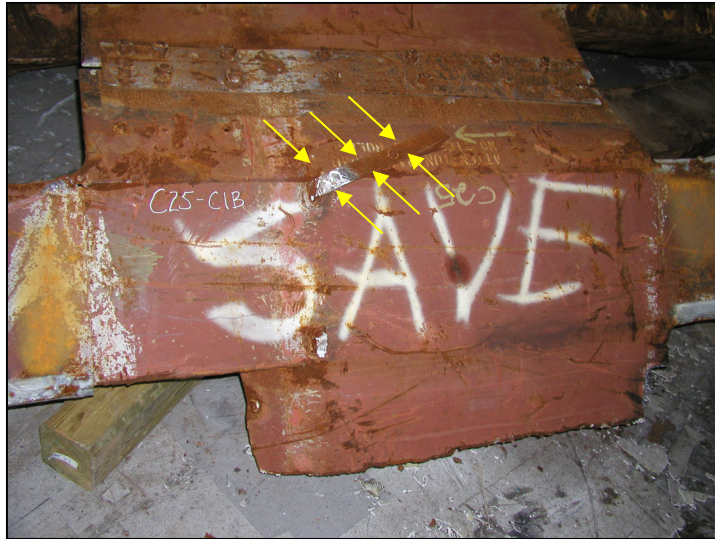
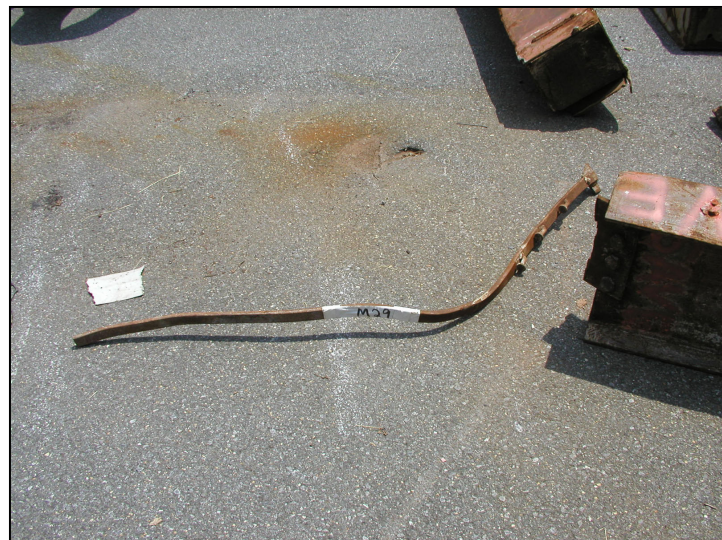
Diagonal bracing strap attached  
directly to exterior column

**Figure 1–5. (left) Diagonal bracing strap shown on sample C-25, (top), and  
single strap labeled M-29 (bottom).**

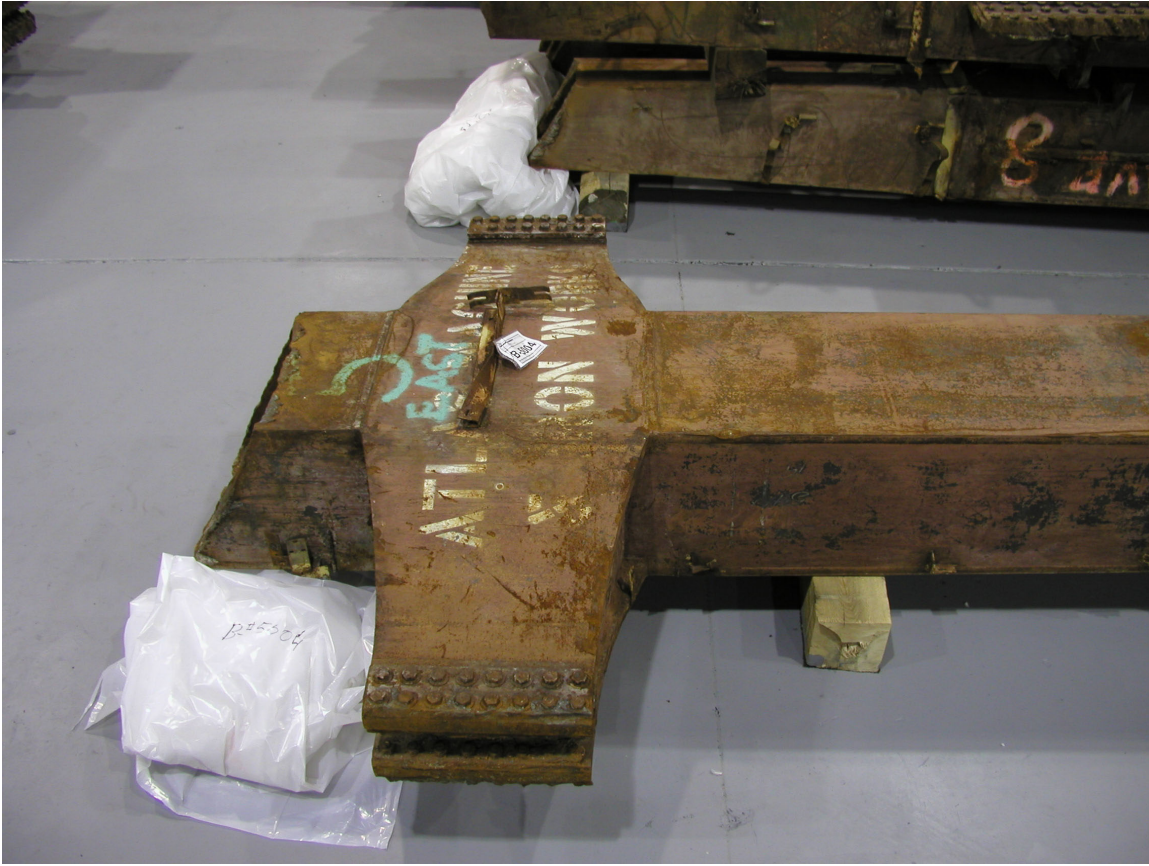
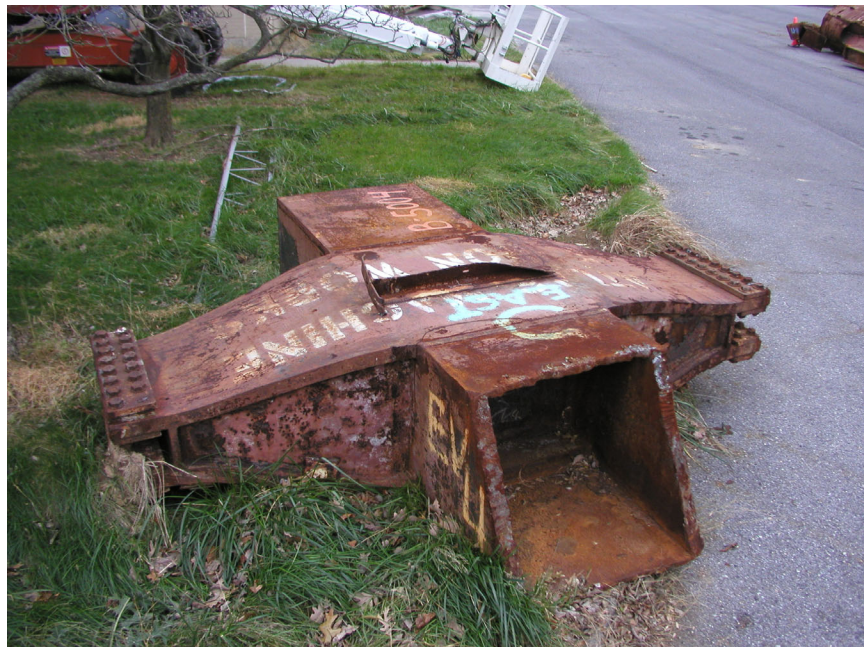
B-5004 at JFK

B-5004 portion cut and moved to NIST campus

**Figure 1–6. Bowtie section of exterior wall.**

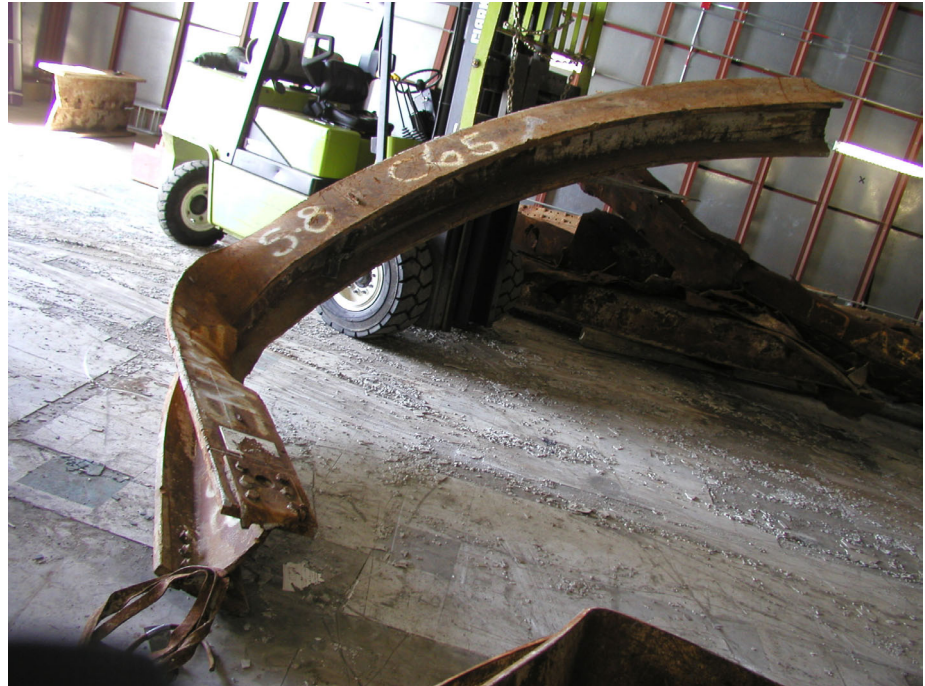
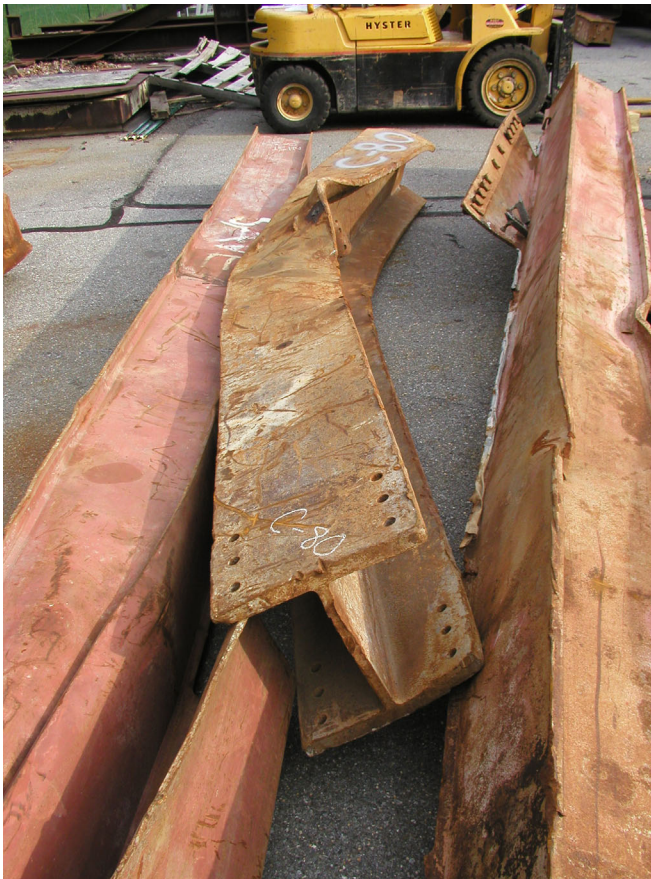
**Figure 1–8. Recovered wide flange sections used as core columns.**

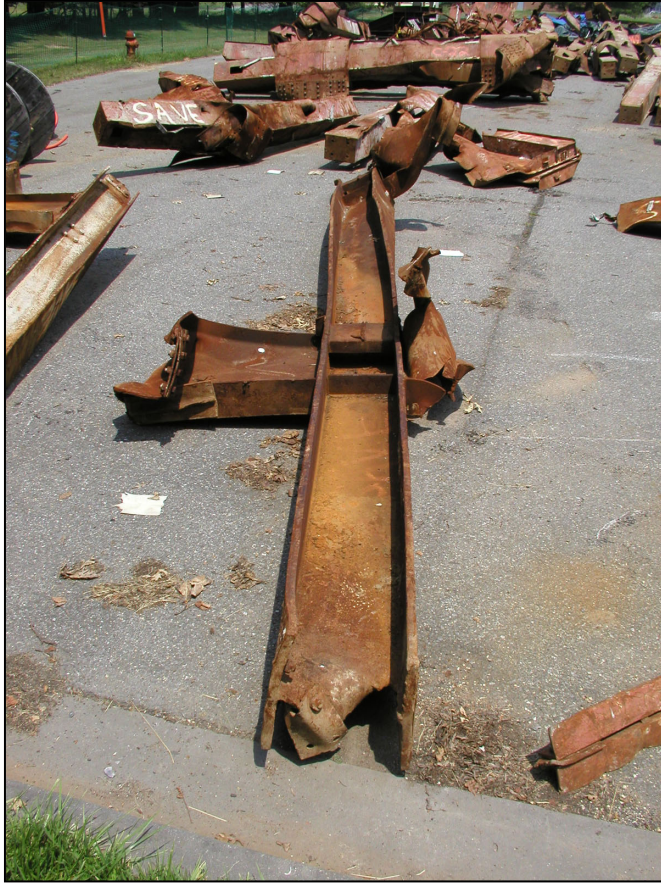
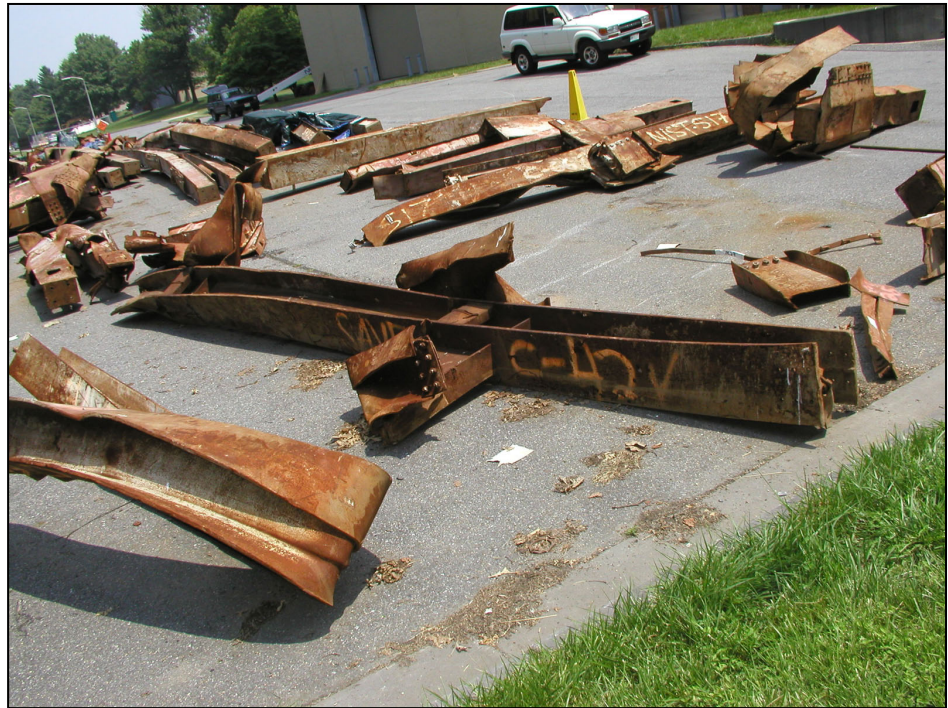
**Figure 1–9. Other recovered wide flange sections, shown is sample C-42.**

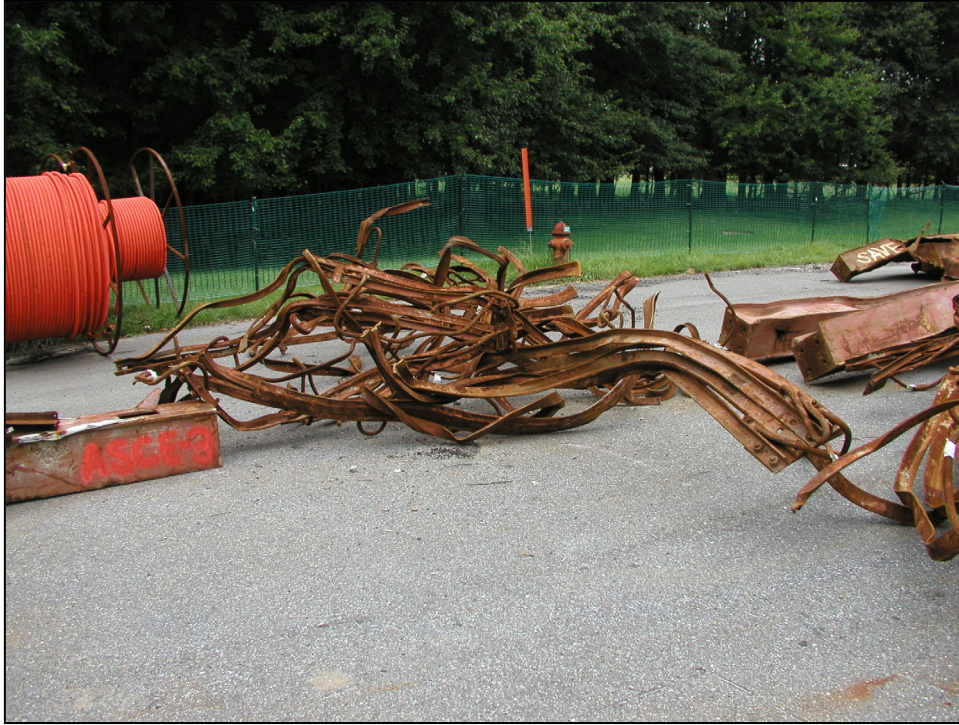
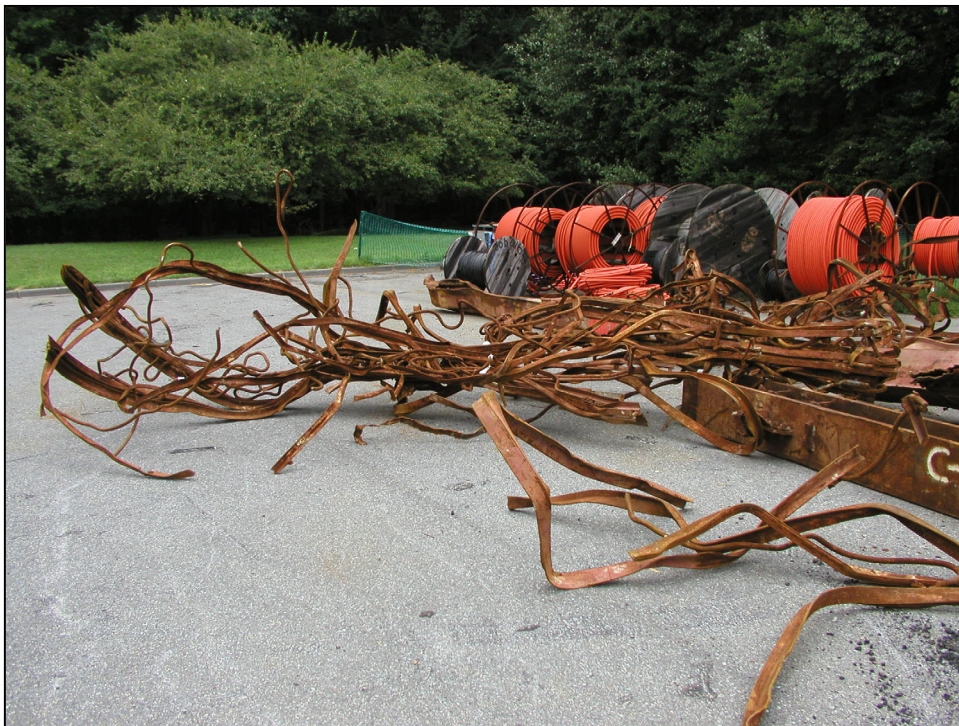
**Figure 1–10. Recovered floor truss material, shown are portions of sample C-53.**

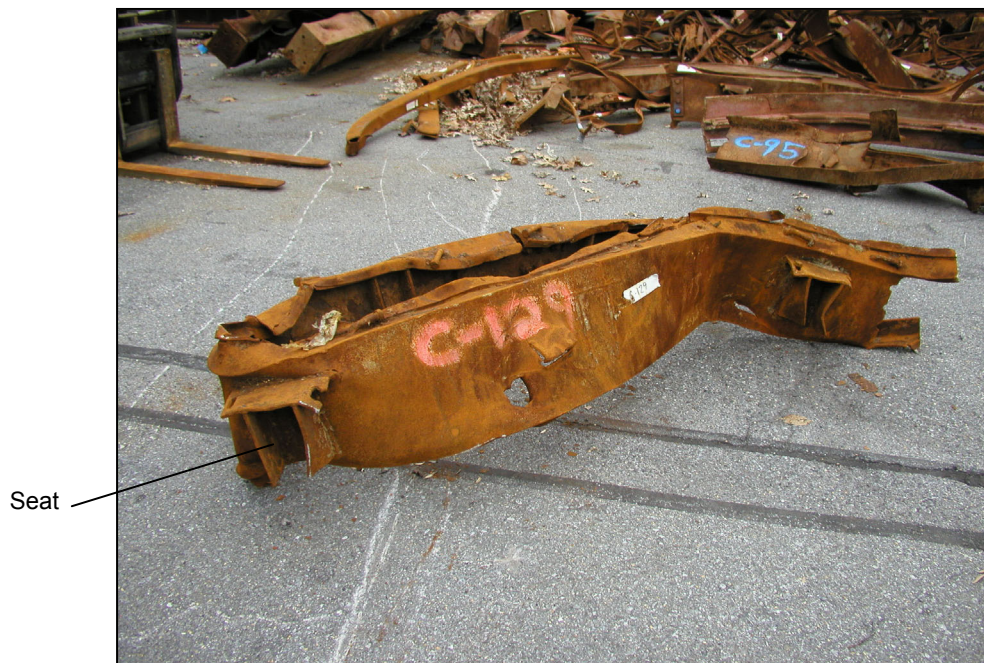
**Figure 1-11. Recovered inner channel material used to connect floor trusses to core columns; shown is sample C-129.**

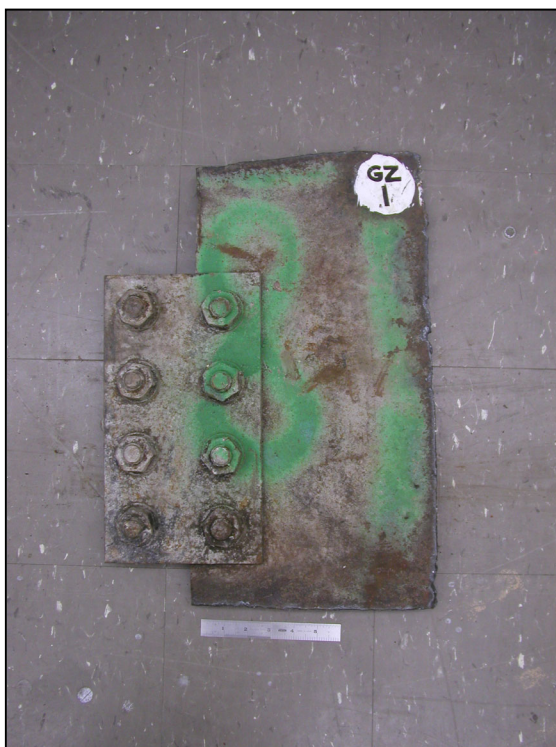
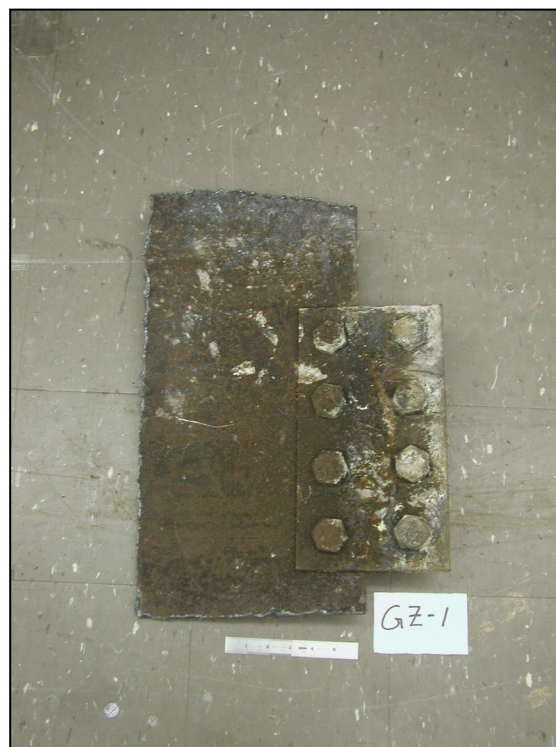
**Figure 1-12. Coupons removed in the field from WTC 5; shown is sample GZ-1.**

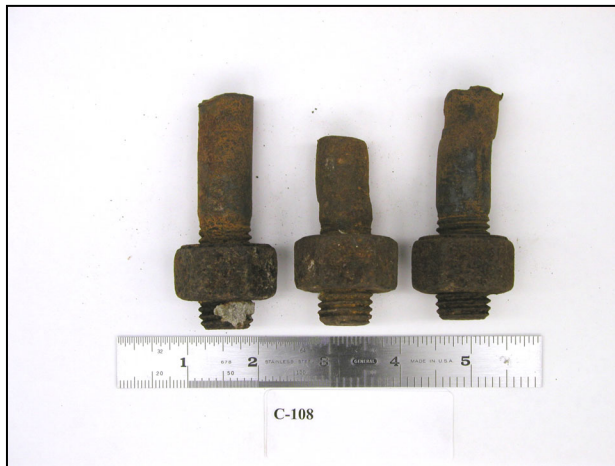
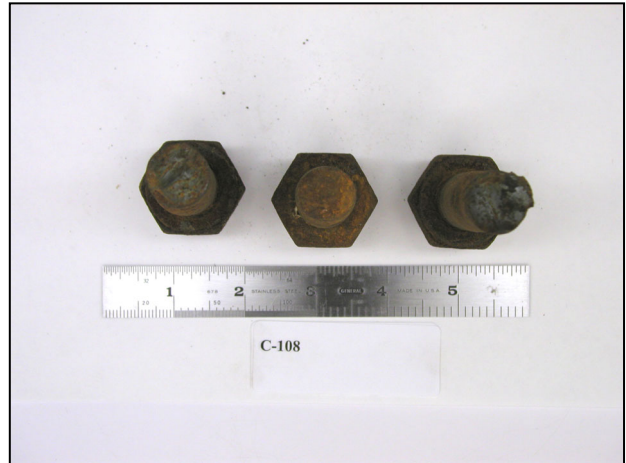
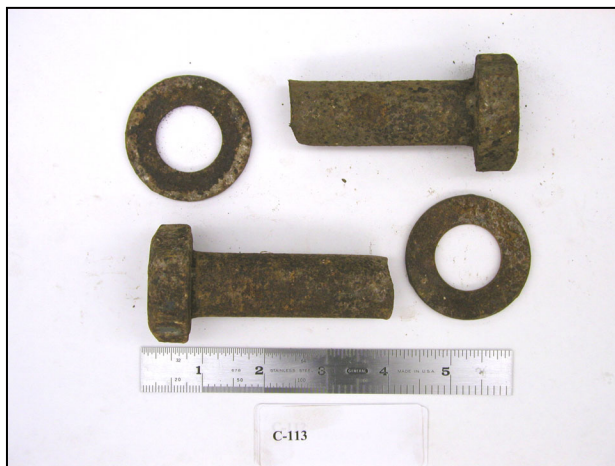
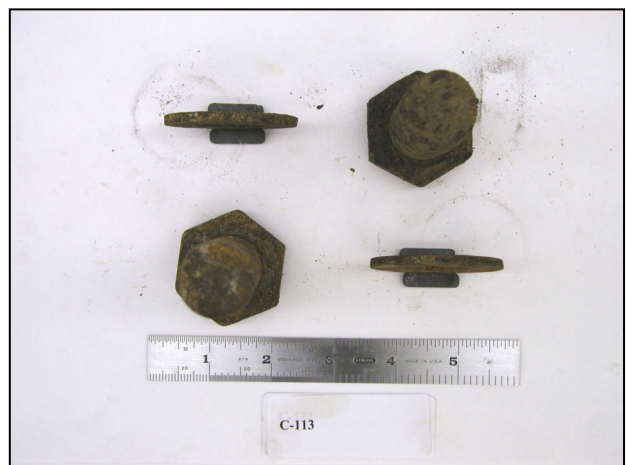
Figure 1–13. Examples of recovered bolts from various samples.

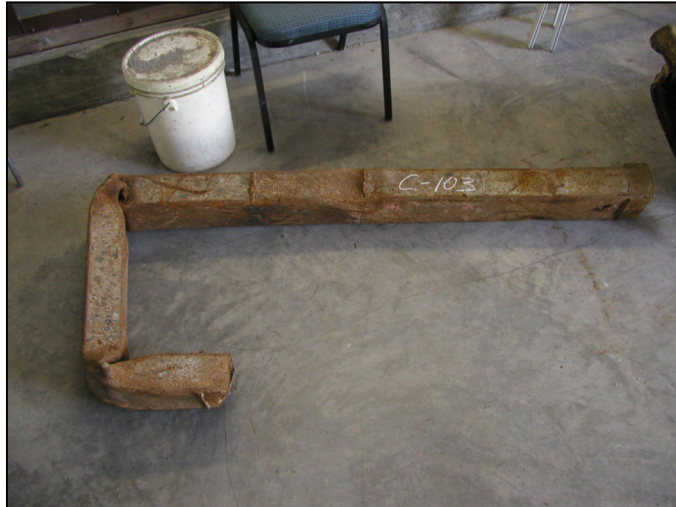
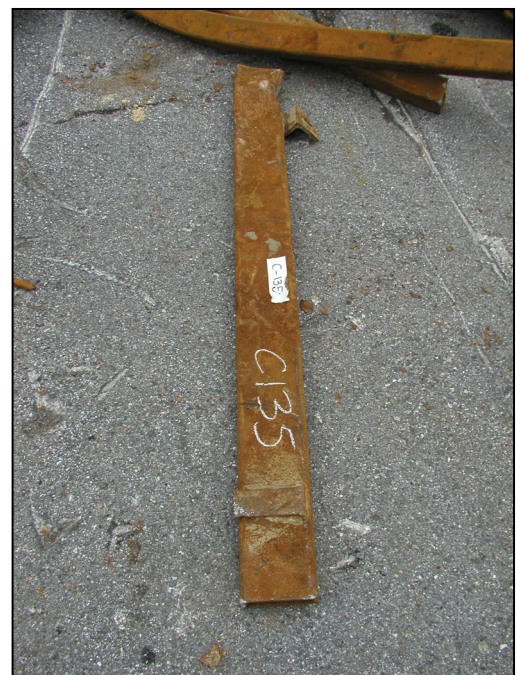
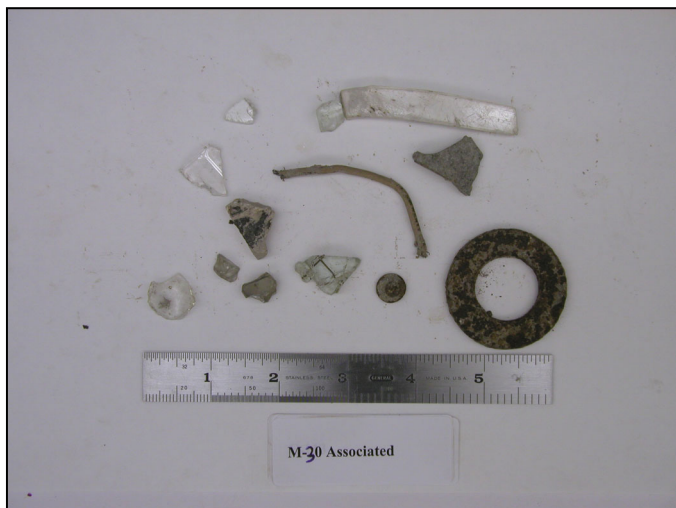
Square tubular piece  
Sample C-103

Rectangular tubular piece  
Sample C-135

Assorted pieces from within column  
Sample M-30 Associated

**Figure 1–14. Examples of miscellaneous materials recovered.**
